Reconstruction of La Fenice theatre in Venice. Foundation problems

A. Balossi Restelli, R. Tornaghi, A. Pettinaroli & E. Rovetto

Consultants, Studio Dr. Ing. Achille Balossi Restelli, Milan, Italy, studio.abr@betam.it

KEYWORDS: excavations, foundations, micropiles, plastic grouts, jet grouting, "berlinese" diaphragm

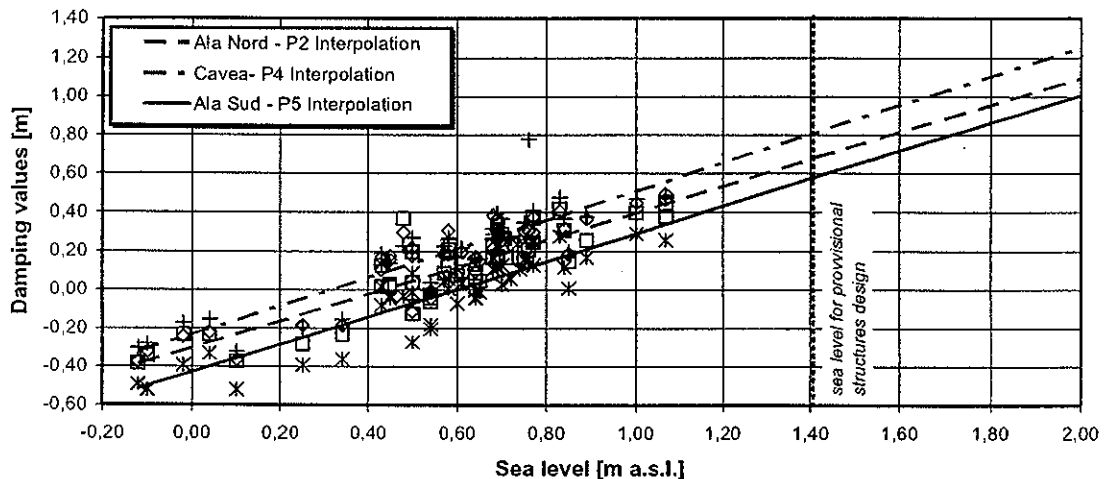
Figure 2. Difference between sea level and watertable levels in piezometers vs. sea level.

In figure 2, damping values of the hydraulic head taken from 3 piezometers versus the sea level and their linear interpolation are shown. The largest damping was observed in the most internal area of the theatre (Cavea), whereas the smallest one in Ala Sud close to Rio de la Fenice. Introducing the water level assumed for the temporary work design (+1,40 m a.s.l.) the hydraulic head was obtained in the various zones for stability analysis against hydraulic uplift. For instance, in Ala Sud the damping value was 56 cm and the resulting water level was +0,90 m a.s.l..

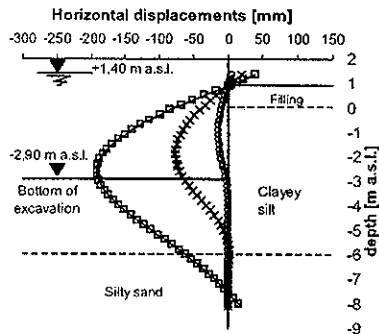
Figure 4. Calculated displacement of the "berlinese" piles

The treatment effectiveness was proved by finite element analysis. In figure 4 the computed horizontal pile displacements are shown; three cases were analysed: no jet treatment (\square), 3 m thick jet grouted layer above the pile bottom (\otimes) and 5 m thick jet grouted layer below the excavation bottom (\odot). The last solution was adopted since it strongly reduces pile bending. During the excavation, no significant displacements of masonry walls were shown by monitoring systems.

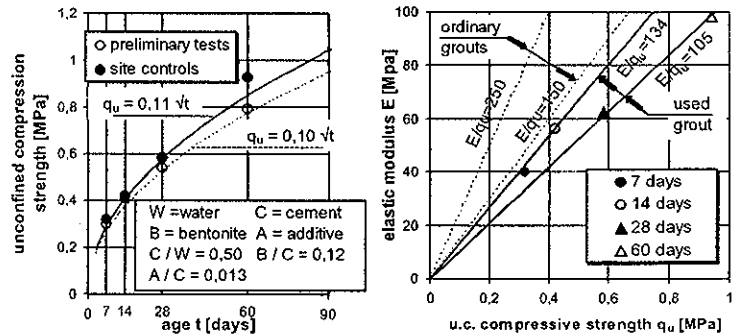
Figure 5. Plastic grouts mechanical properties
a) u.c. strength vs. curing time b) E vs. u.c. strength

Therefore plastic piles Ø230 mm were cast using cement-bentonite grouts with an additive enabling to optimize the rheological and mechanical properties (stability, workability, lower elastic modulus to compressive strength ratio). In figure 5a mean values of strength vs. curing time t are shown, comparing the results of preliminary tests to those of the controls on samples taken on the site; the two sets of data are very much alike, showing an increase of q_u fairly proportional to the square root of t .

As regards deformability, the mean values of elastic modulus E are plotted in figure 5b vs. u. c. strength at different curing times. The E/q_u ratio (about $100 \div 130$) shows a good relative deformability, enhanced by the additive, which allowed the use of the greatest bentonite/cement ratio consistent with workability and strength demands; in fact the E/q_u values for ordinary cement-bentonite mixes are sensibly higher as shown in the same plot (statistical range between 150 and 250).

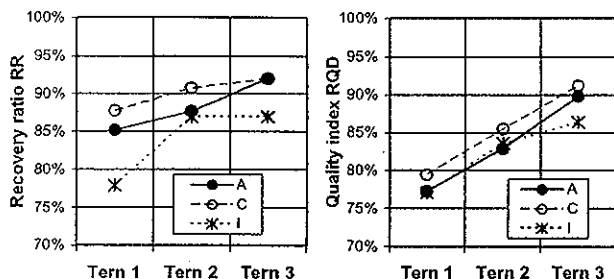
Figure 7. Jet grouting field trial: average core recovery parameters (control boreholes)

In figure 7 mean values of coring parameters RR and RQD are compared.

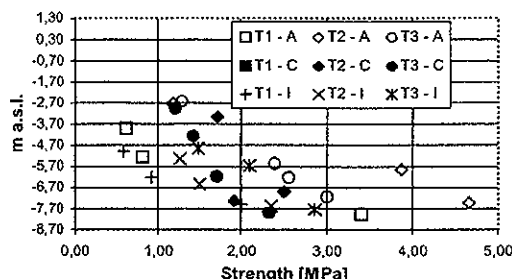
Figure 8. Jet grouting field trial: specimen strength vs. depth

- bulk density increasing with depth from 16 kN/m³ to about 17,5 kN/m³
- a similar trend as regards strength (figure 8) with general mean values increasing from 1,2 MPa in clayey silt to 2,8 MPa in the underlying sandy layer.

The higher strength values have been obtained in type A corings, the lower ones in inclined borings I. On an average, strength is of the same order in terms 2 and 3, and sensibly higher than in the first term. According to these results, the jet grouting parameters of term 2 have been chosen.
